Windstorm Mitigation Report (OIR-B1-1802)

Tuscany By The Sea Condominium Association, Inc.

19520 Gulf Blvd, Units 201-702

As of 05-06-2025 | FPAT File# MUD2523801

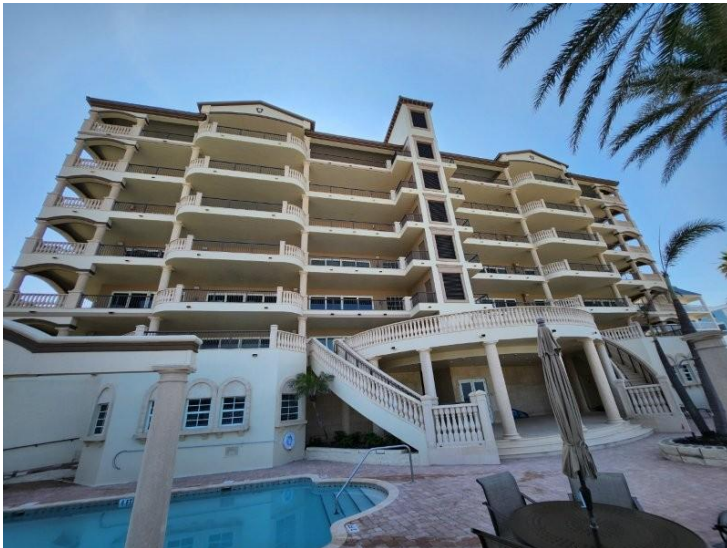
Exterior Elevation

Comments: | Other Roof
Inspection verified flat and gable roof shapes. The flat portion comprises +/- 11% of the total roof area. |

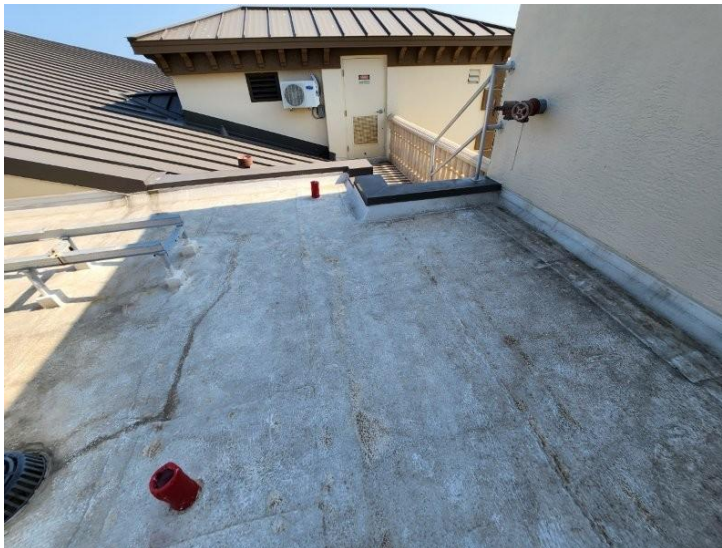
Roof Construction

Comments: | Level C
Inspection verified 5/8" plywood roof deck attached with 8d nails at a minimum 6" on the edge & 6" in the field. |

Comments: | Single Wraps
Inspection verified single wrap metal straps installed on each truss/rafter that wrap over the top of the truss / rafter and attach to the wall frame in one location. |

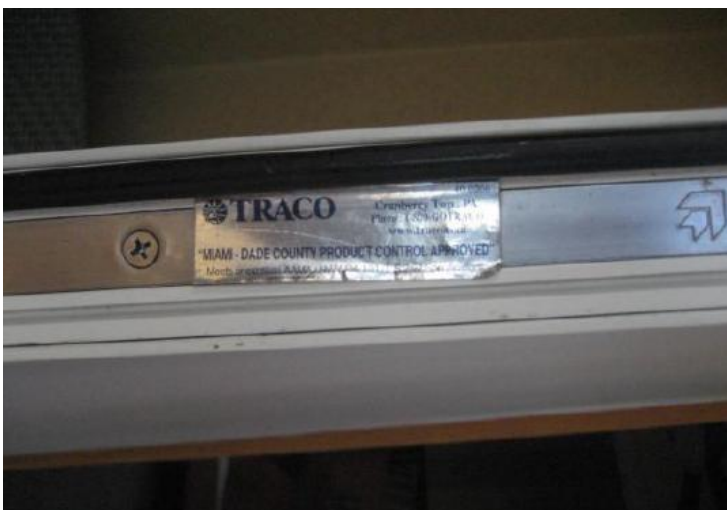
Opening Protection

Comments: | Exterior Openings Cyclic Pressure & 9-lb Large Missile
Inspection verified Miami Dade County Approved large missile impact rated doors, windows and sliding glass doors. (See attached documentation) |
